## Test Report

No.: CANPC26015115306\_1

Sample Name: Spc Composite Wall Pane

**Asbestos**

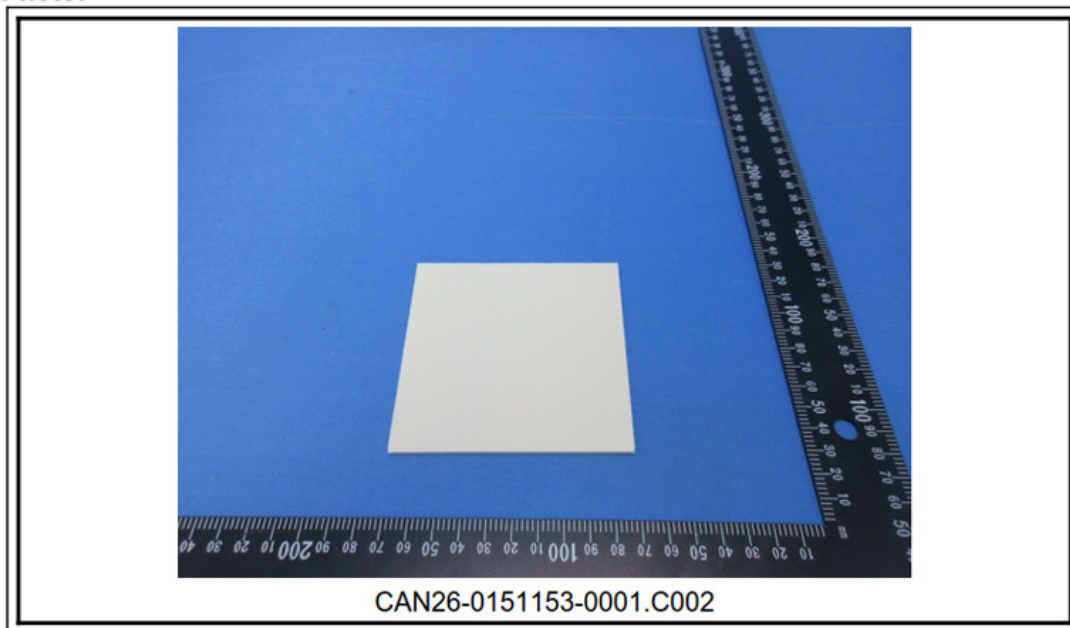
Sample Photo:

| SN ID | Sample No. | SGS Sample ID | Description |
|---|---|---|---|
| SN1 | 002 | CAN26-0151153-0001.C002 | Light gray board with beige surface |
